FILE COPY
Special Report 89-4

*Radar profiling of Newton Airfield
in Jackman, Maine*

Carl R. Martinson

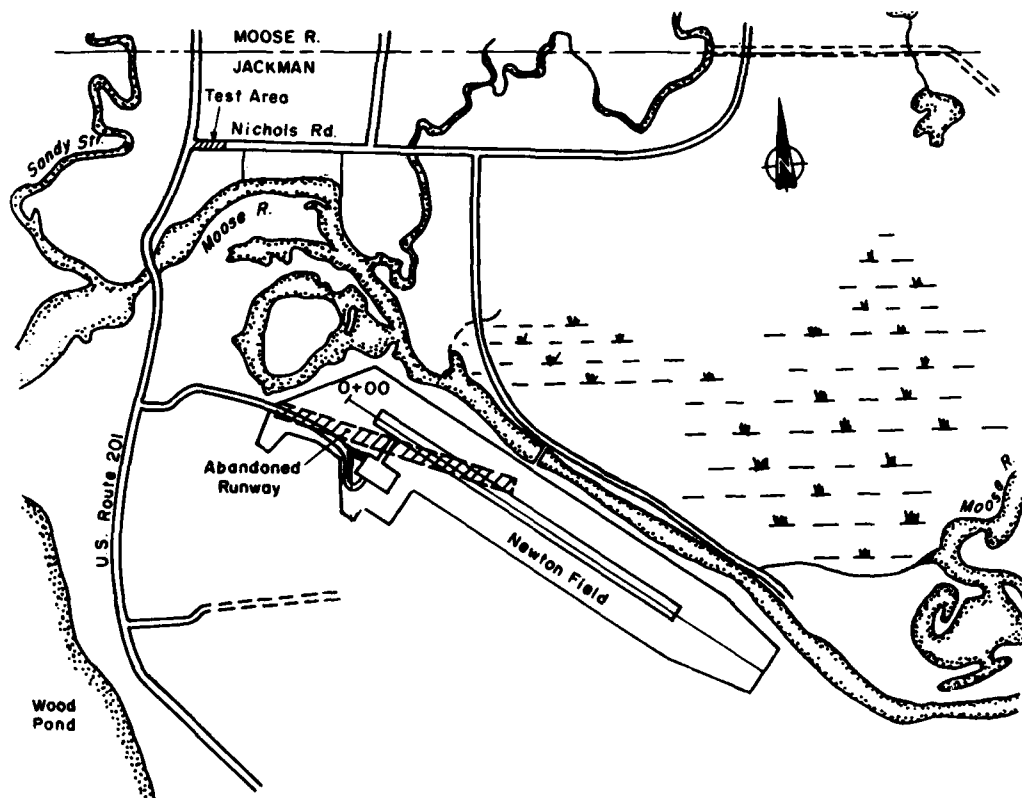
Figure 1. Newton Field, Jackman, Maine.

a. Layout of airfield with Nichols Road test section shown.

On 25 and 26 April 1987 ground-penetrating radar was used to observe subsurface conditions of Newton Field, an airfield in Jackman, Maine. The layout and a typical cross section of the runway, constructed in August through October 1986, are shown in Figure 1. The surface was paved with 1.5 in. of asphalt. Below that is 12 in., average depth, of clean bank run gravel. Next is a 2-in. layer of extruded polystyrene supported by 1 to 3 in. of a sand leveling course. Under the sand is a geotextile fabric and beneath that is the natural subgrade of silty sand. Subsurface tem-

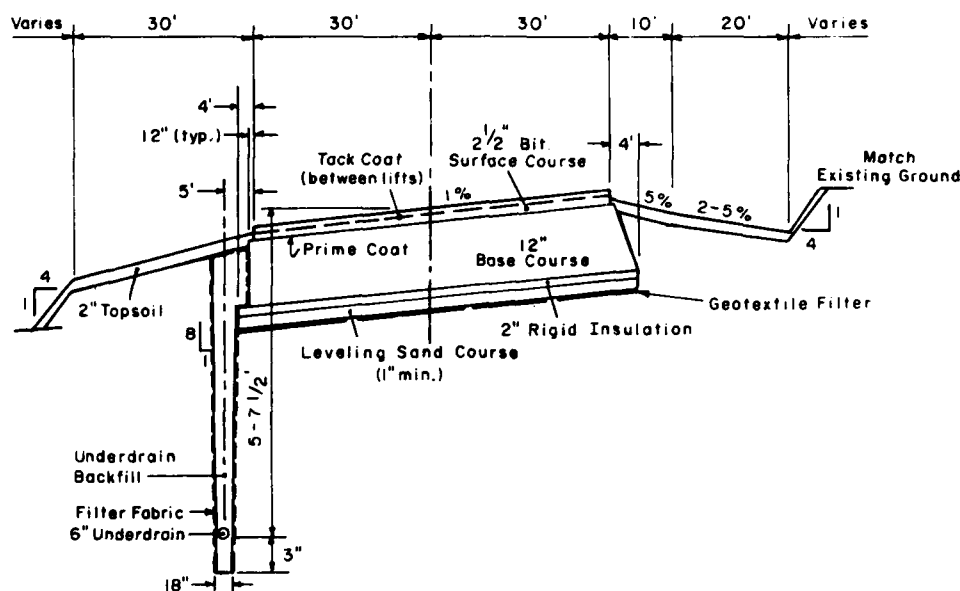
Figure 1 (cont'd). Newton Field, Jackman, Maine.

b. Cross section of airfield.

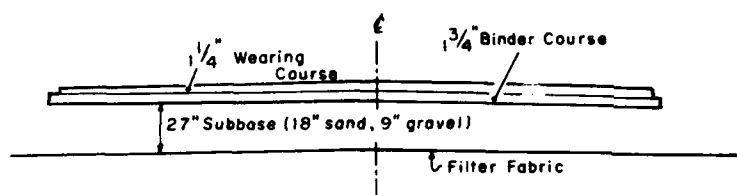
Figure 2. Nichols Road, Jackman, Maine.

a. Cross section of first 150 ft, station 2+00 to 0+60, the end of the radar survey.

Figure 2a shows a typical cross section of the reconstructed part of Nichols Road. Part of this road was included in the survey for comparison. A longitudinal cross section, from the plans for the road reconstruction, is shown in Figure 2b.

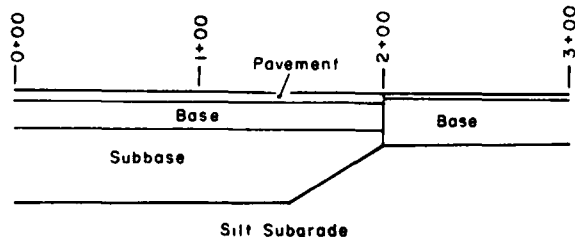
b. Longitudinal cross section.

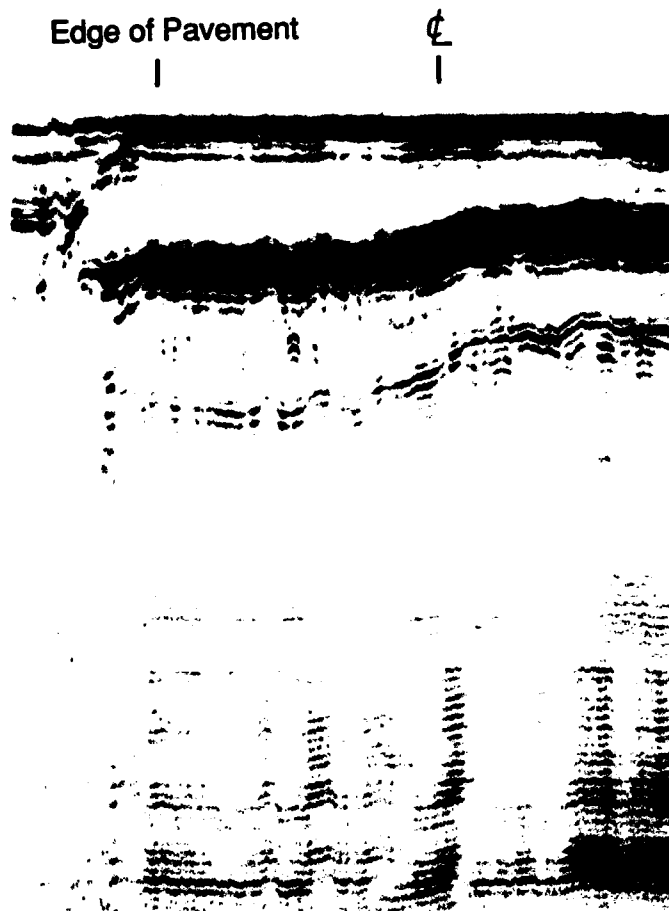
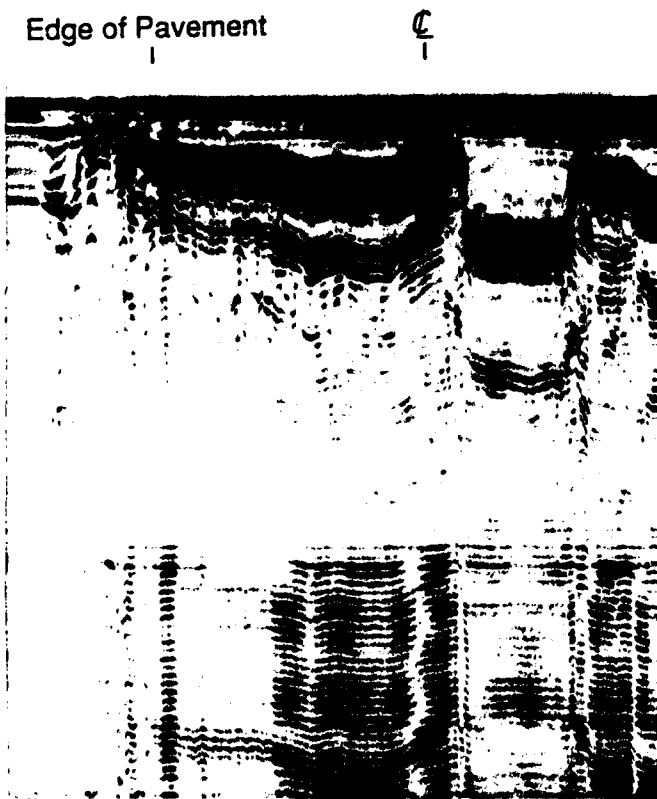
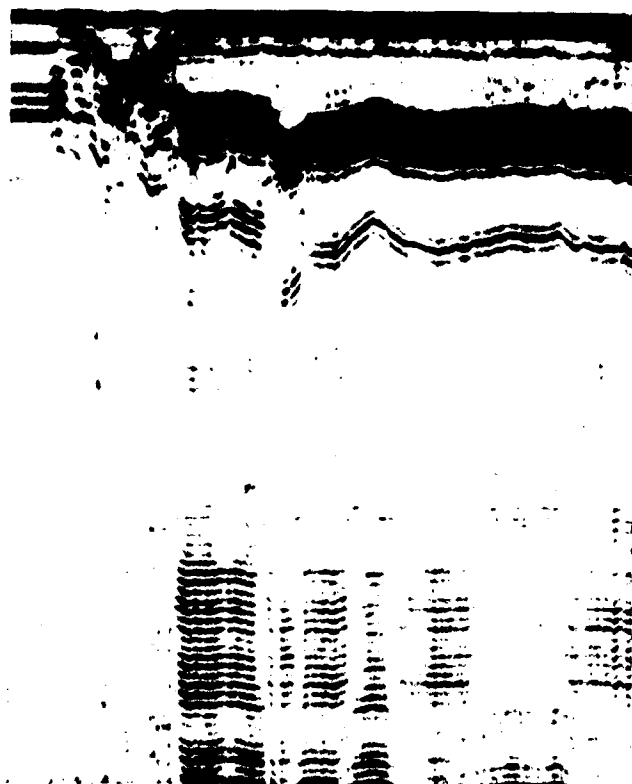
Figure 4. Ground truth profiles for three stations at the pavement edge.

a. Cross section at station 7+00.

b. Cross section at station 8+00.

c. Cross section at station 9+00.

The graphic record shows that the time delay of signal reflection from the insulation layer does not change abruptly with depth from the unpaved to the paved portions of the surveyed lines (Fig. 4 and 5). It is assumed, therefore, that the signal velocity is the same for the gravel beneath the paved and unpaved portions of the runway. The number of calibration measurements may

The cross-sectional data (Fig. 4 and 5 and Table 2) also show some depth variation within a survey line and from cross section to cross section. The insulation at stations 8+00 and 8+17 generally appears closer to the surface than elsewhere in the survey.

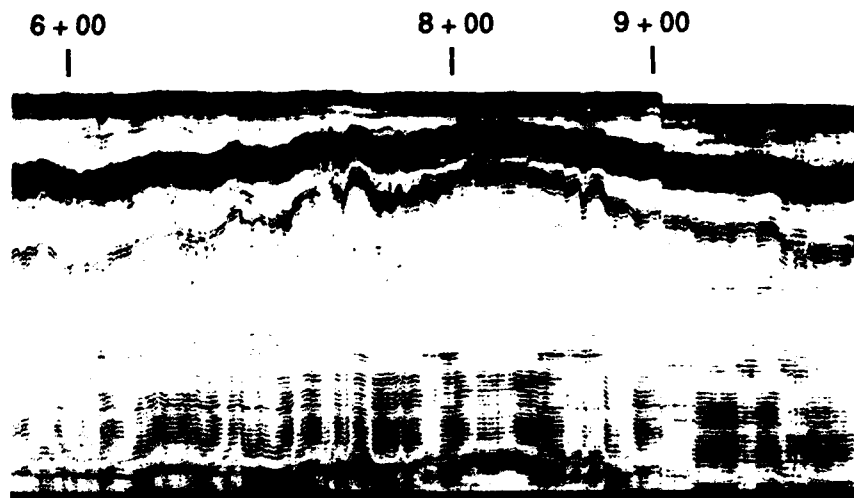
Figure 6. Centerline survey passing through station 8+00 where the insulation appears nearer the surface. The shift at station 9+00 is caused by equipment malfunction.

During the course of the ground-penetrating survey, we noticed an asphalt patch that began near the centerline of the runway and extended about 10 ft to the south. It was approximately 40 ft long and passed through station 8+00. Figure 6 shows that the insulation interface is apparently closer to the surface near station 8+00 than

tween stations 3+00 and 2+00. Whatever the cause, there is a distinct change in the graphic record at station 2+00. Another obvious and more important feature is the omission of the return that occurs on the runway survey (Fig. 6) and represents the apparent gravel/insulation/sand interface. Although there are some returns at depths corresponding to 12 to 15 ns, there is nothing as obvious or continuous as that which occurs on the runway survey. The area encompassed by station 1+50 to 0+00 of the road is identical to the runway, except that the insulation is not present. That being the case the Nichols Road survey supports the idea that the strong returns of the runway survey represent the insulation layer.

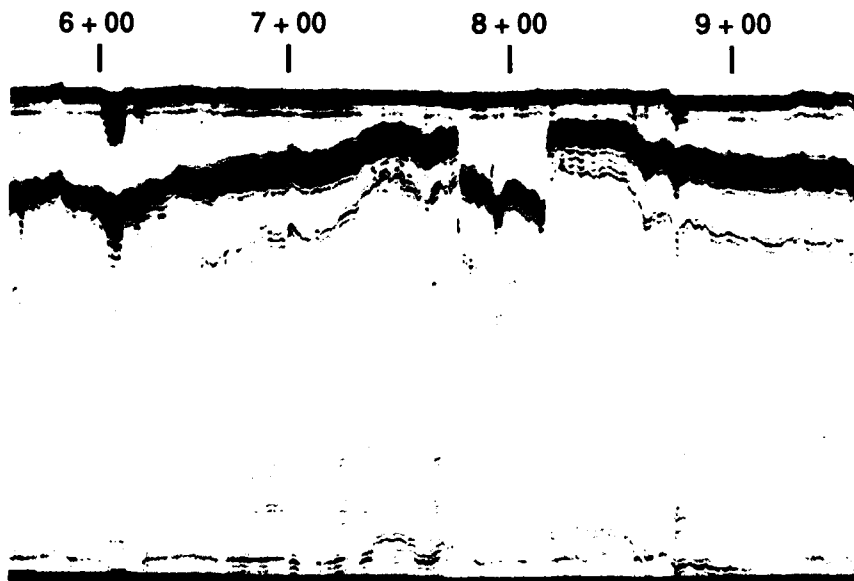
Figure 7. Survey parallel to the centerline and approximately 10 ft south of it, passing through station 8+00 where a discontinuity appears.

to either side of it on the centerline survey. Figure 7 shows a discontinuity approximately 40 ft long, with station 8+00 near the center of it. A cross-sectional survey at station 8+17, documented in Figure 5, shows the same discontinuity for a distance of about 10 ft. The subsurface observations correspond closely in size with the

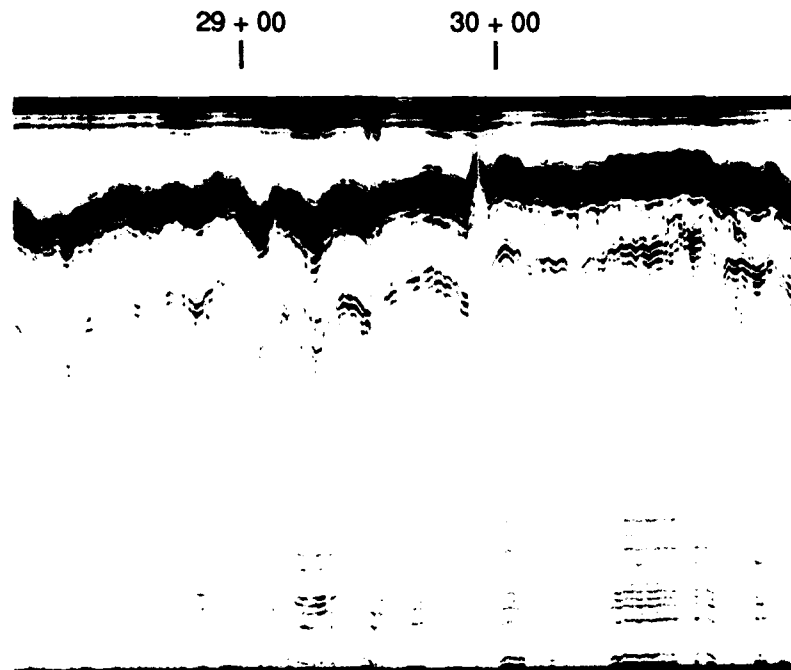
Figure 8. Portion of a typical survey line along the length of the runway. The unusual return at station 30+00 may or may not be related to a crack in the asphalt near that point.

Nonuniformity of the depth of the interface is present throughout the runway survey, although it is not generally as severe as in the area of station 8+00. The returns in Figure 8 are typical, except for the event at station 30+00. At that location a crack extended across the runway. It is speculative to say that the crack and the unusual return are somehow related and it is mentioned only as a possible explanation.

The variation in the depth of the insulation as seen in Figure 8 is also documented in Table 1. The range of depth for the centerline survey is from 7 to 24 in. If the area near station 8+00 is excluded, the range of depth becomes 12 to 24 in. The range for the south line is 5 to 20 in.; including the area near 8+00, the depth range becomes 11 to 20 in. The depth of the insulation appears to be consistently shallower at the east end of the runway for both long surveyed lines.
